NCO HOUSING TYPE 2 A

BUILDINGS 5302, 5303, 5304, 5306, 5307, 5308,
5311, 5312, 5314, 5315, 5317, 5318

CONDITION SURVEY

FIVE UNIT ROW HOUSES

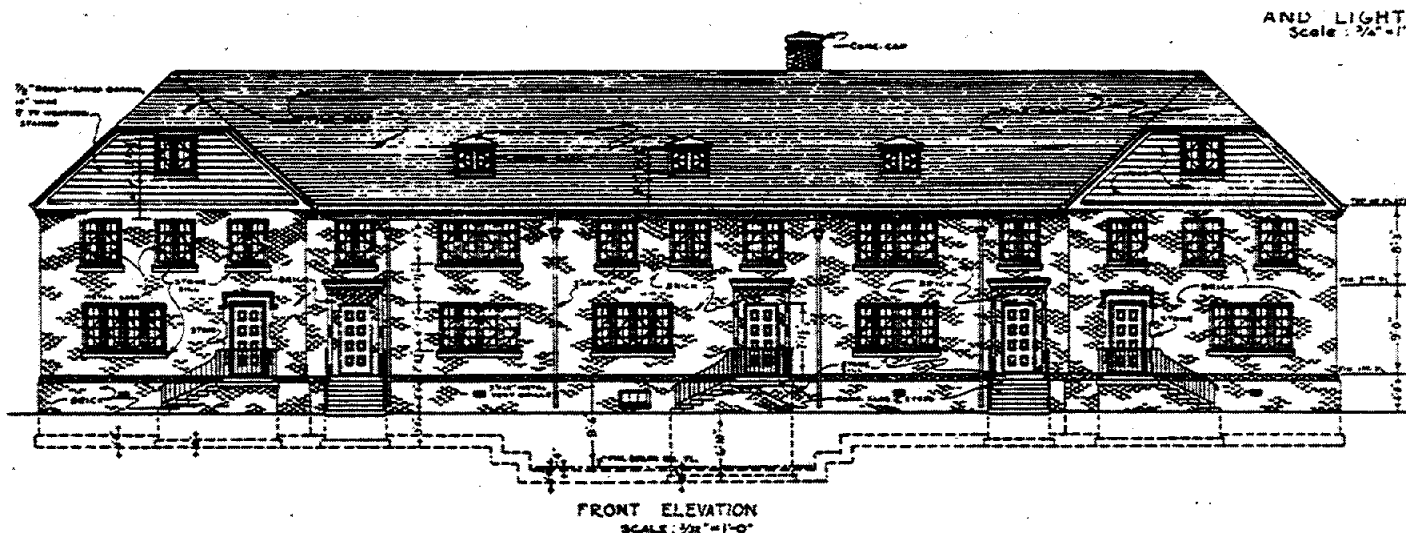
The five unit row houses were constructed in 1940 from standard quartermaster general plans. Except for the addition of rear decks and storage sheds, and the removal of most original porch lights and downspout leader heads, the buildings are close to original design.

The row houses are constructed of brick on concrete foundations. Windows are steel sash, sills and entry portals are stone. The wrought iron railings will need attention shortly due to rust formation at posts.
